ACTIVE BEACON COLLISION AVOIDANCE SYSTEM (BCAS) LOGIC PERFORMANCE DURING OPERATIONAL FLIGHT TESTS

R.A. TORNESE
A.L. MCFARLAND

The MITRE Corporation
McLean, Virginia 22102

JANUARY 1981

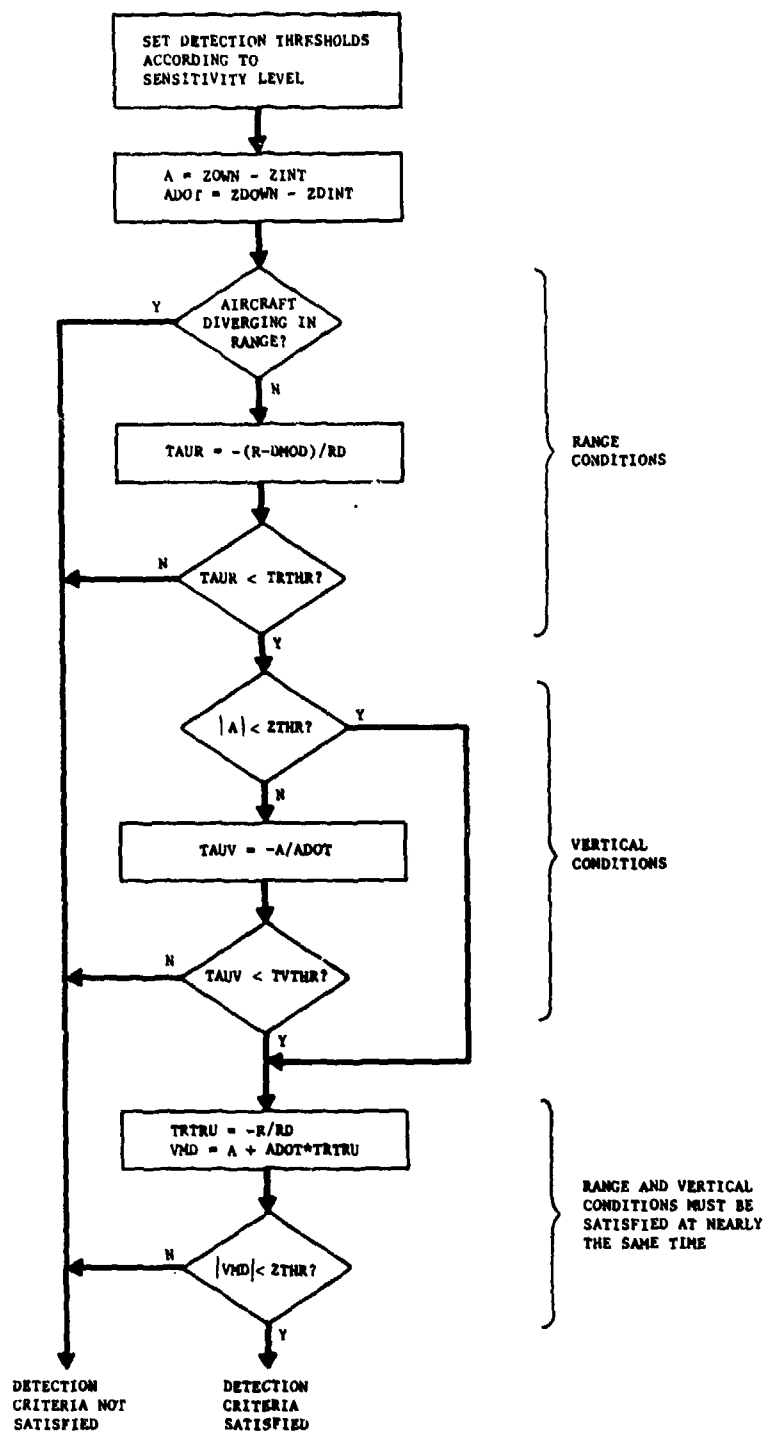
FIGURE 2-2
SIMPLIFIED FLOW CHART OF DETECTION LOGIC

advisory. The period of the modeling is from current time to the estimated time of closest approach (TRTRU, or -R/RD). If TRTRU is too far into the future a maximum look-ahead time is used for the projection. The BCAS aircraft is modeled as accelerating/decelerating at $1/4g$ to the assumed escape rate and then maintaining that rate until time TRTRU. The intruder is modeled as maintaining its current vertical velocity. Then a projected vertical separation at time TRTRU is calculated based on the modeled climb and descend maneuvers of the BCAS aircraft. If the climb maneuver will provide a separation at TRTRU greater than or equal to that of the descend maneuver, then the climb sense is chosen. Otherwise, the descend sense is chosen.

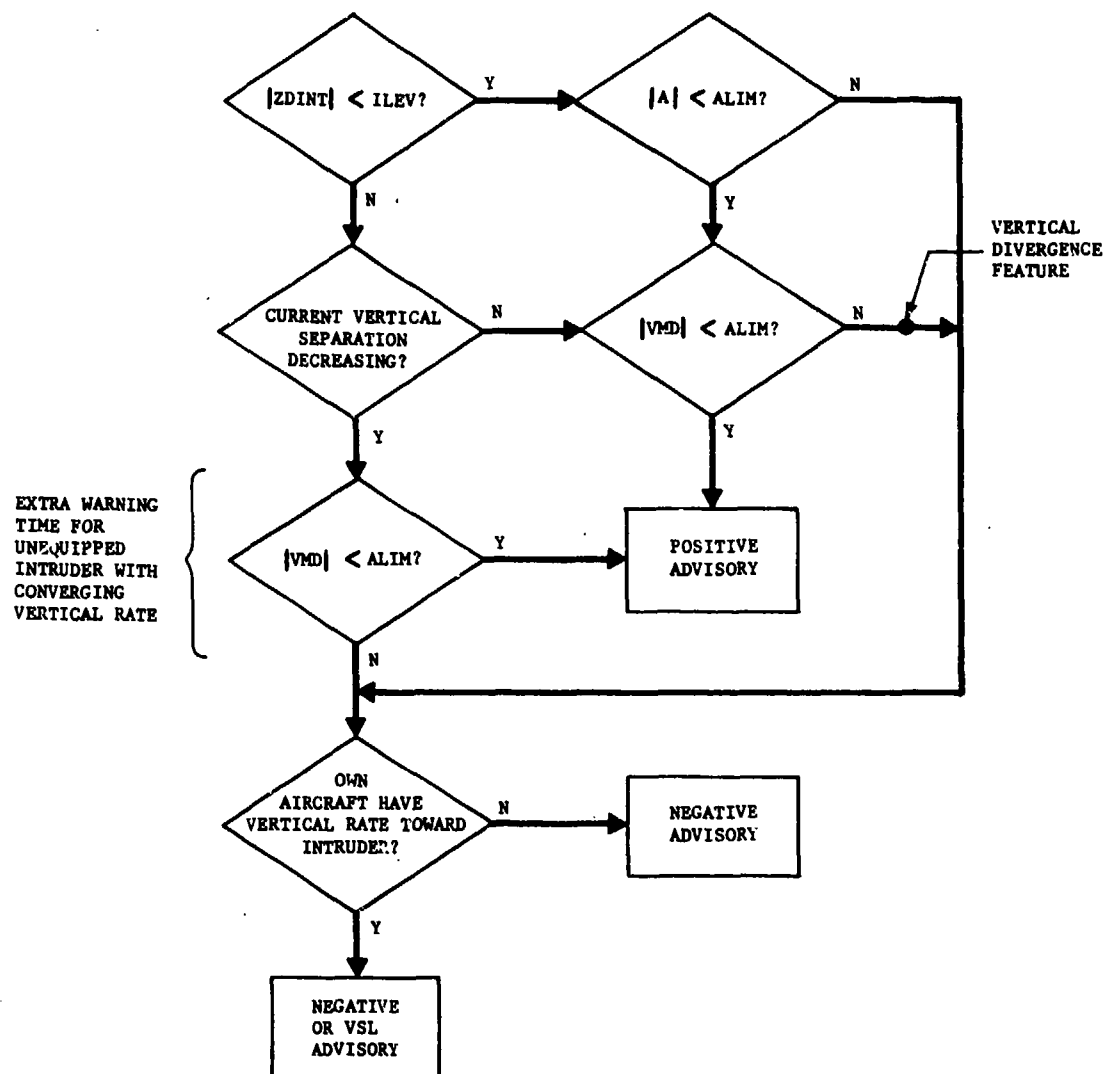
A flow chart of the simplified advisory type selection logic is presented in Figure 2-3. This flow chart shows only the logic applying to unequipped threats, since only the logic for unequipped threats was exercised in the operational flight tests. Slightly different logic is used for equipped threats. In Figure 2-3 the two VMD tests could be combined into one to achieve the same logical effect as the flow chart shown. However, the two tests are shown separately to illustrate the two roles played by VMD -- providing extra lead time for unequipped intruders with converging vertical rates, and avoiding positive advisories in a vertical divergence situation.

FIGURE 2-3
SIMPLIFIED FLOW CHART FOR DETERMINING ADVISORY TYPE

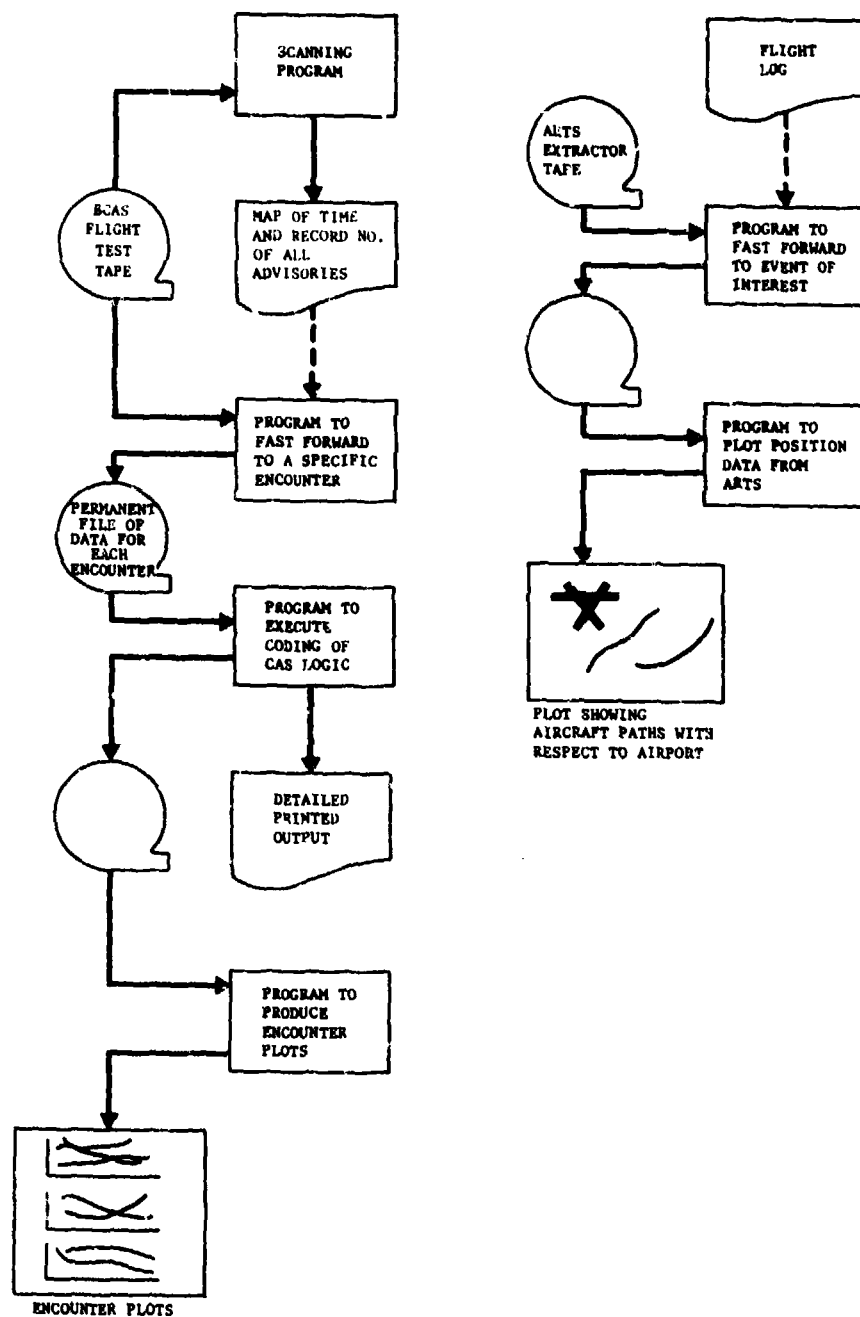
**FIGURE 3-1
FLIGHT TEST DATA ANALYSIS PROCESS**

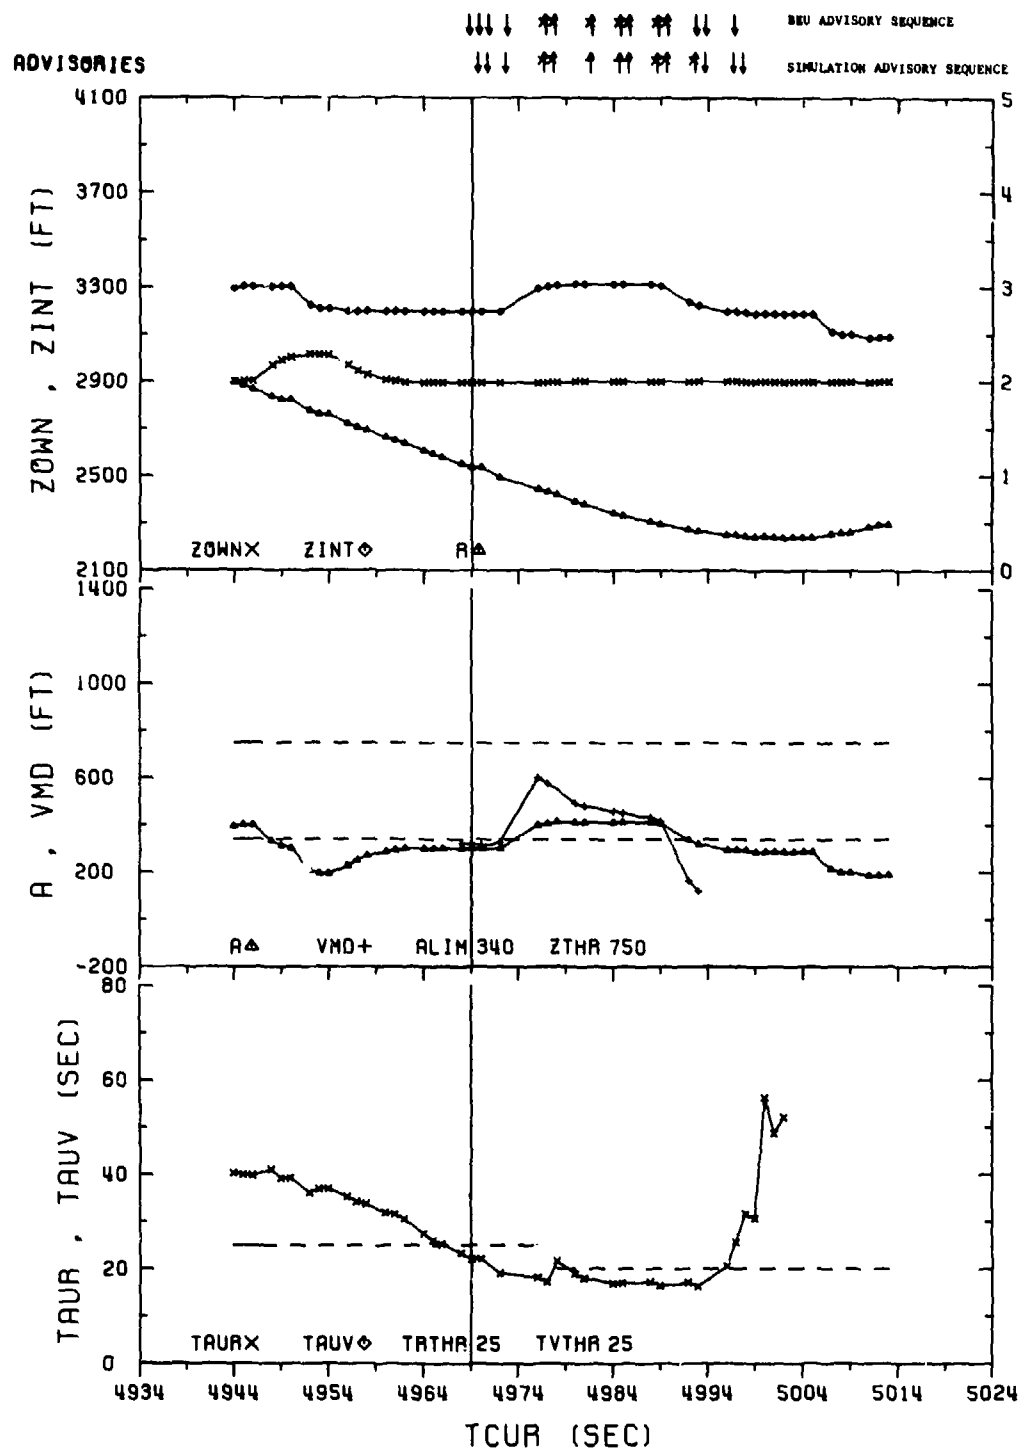
FIGURE 4-1
SEPARATION, TAU PLOTS FOR ENCOUNTER 1 AT DALLAS

Examination of each aircraft's altitude profile in Figure 4-1 shows that the BCAS gave the correct sense advisory. The BCAS aircraft was below the threat, with current and projected vertical separation less than ALIM, which resulted in a descend advisory. A slight altitude excursion by the intruder resulted in the advisory transitioning to negative, then to a VSL and then back to a positive as the intruder came back within ALIM feet of the BCAS aircraft. The encounter ended as the TAUR value increased above the threshold of 20 seconds, just prior to closest approach.

The number of advisory transitions appears to be excessive. However, it should be noted that they were all caused by maneuvers on the part of the intruder, not the BCAS aircraft. Had the BCAS aircraft responded to its advisory, the advisory would have transitioned to a negative after only a 100 ft descent by the BCAS aircraft. Then the advisory would have stayed a negative until dropping at horizontal closest approach.

The gaps in the data seen in the simulation plots are caused by the buffer overflow problem discussed in Section 3. Advisories are shown on the plots only when there is data recorded on the tape. Therefore, gaps are seen in the advisory sequence also. These gaps did not occur in the advisories displayed on board the aircraft during the tests and they do not occur in normal operation of the BCAS logic. The BCAS operation and advisory display were not affected by the tape recorder problems.

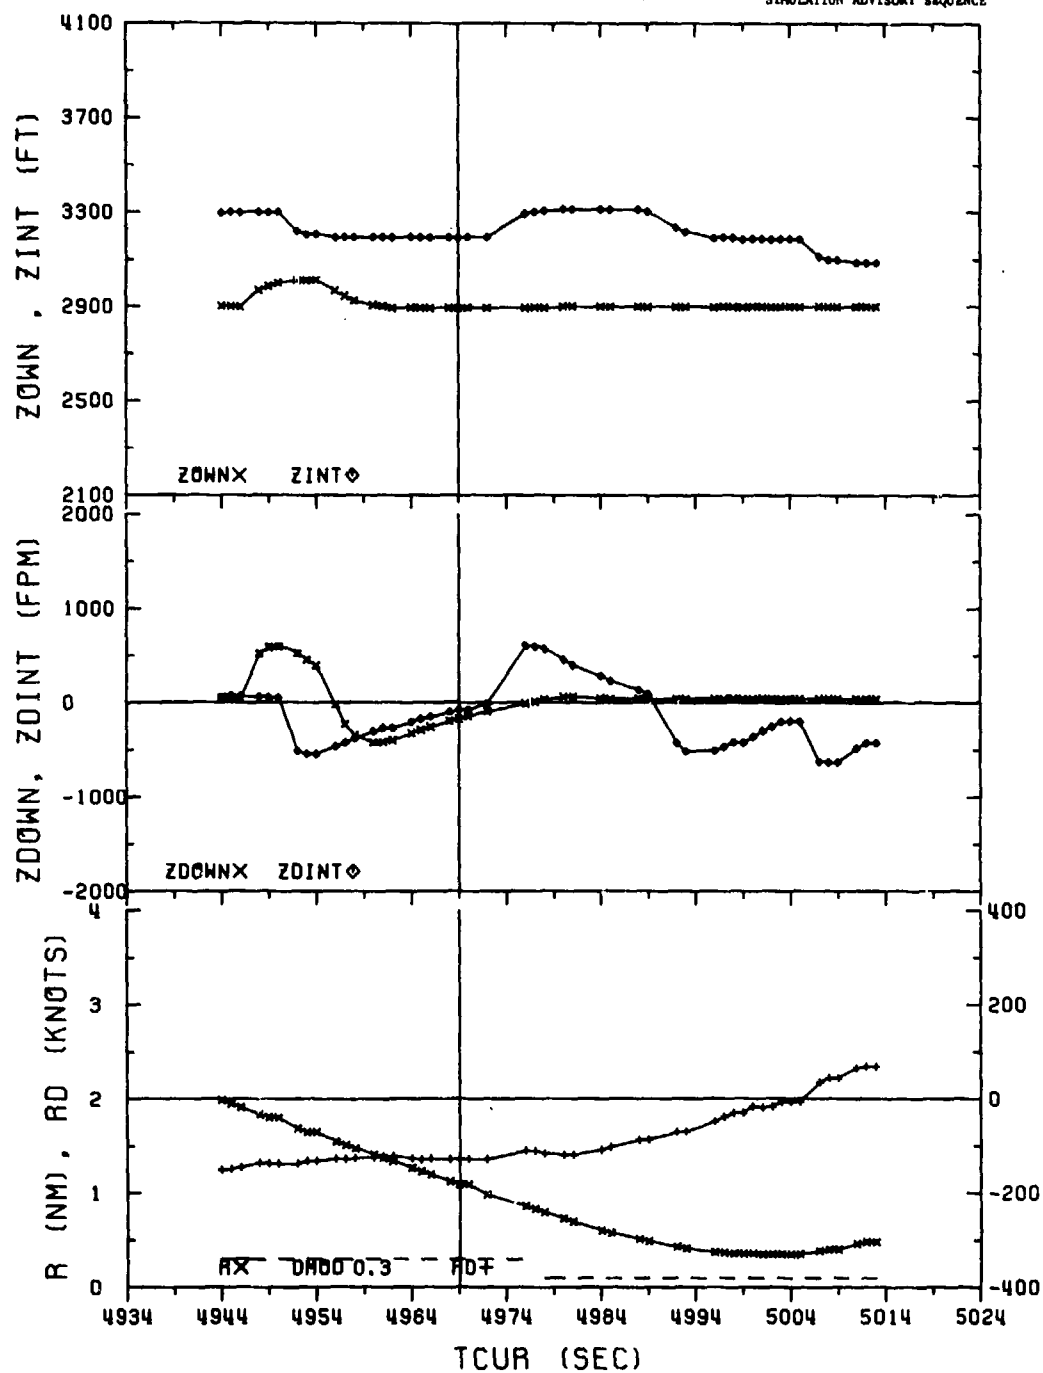
FIGURE 4-2
SEPARATION, RATE PLOTS FOR ENCOUNTER 1 AT DALLAS

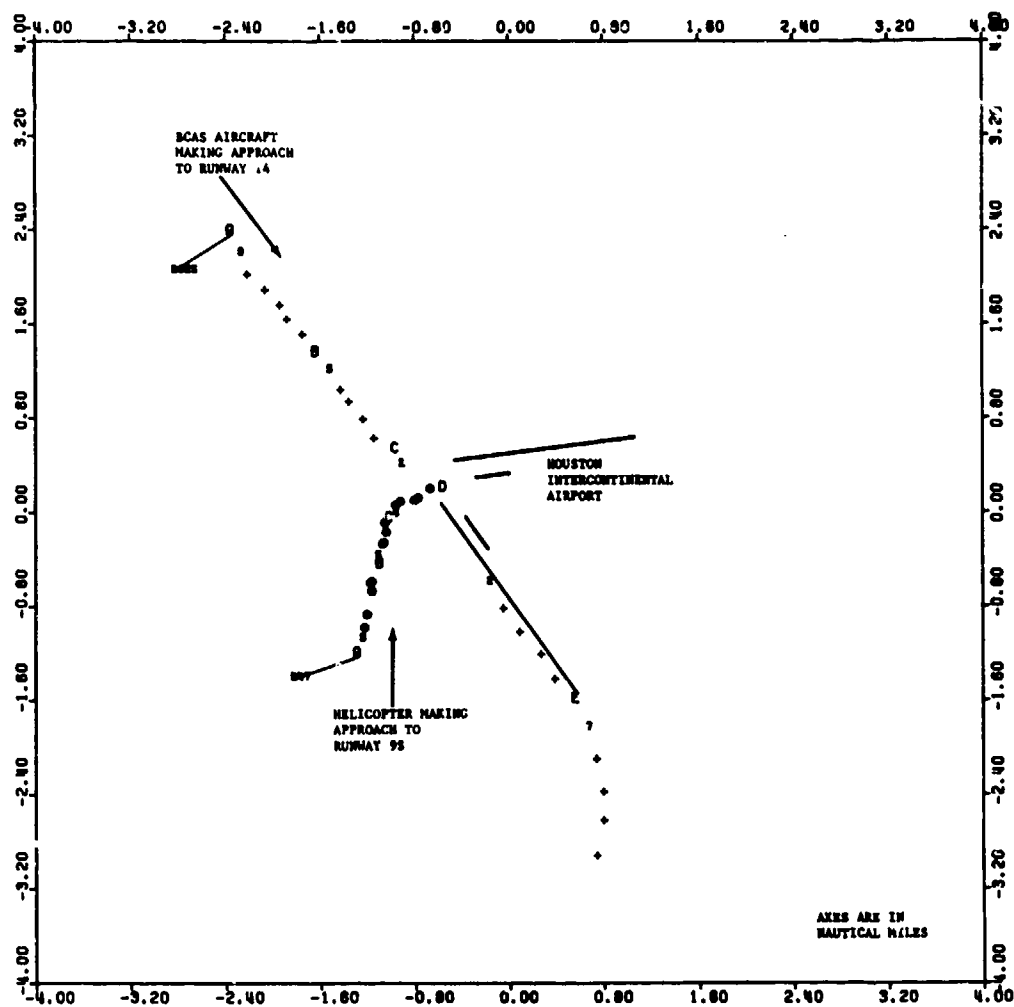
FIGURE 4-3
ARTS PLOT OF ENCOUNTER 2 AT HOUSTON

scan of the ground radar. Every 30 seconds the character used to plot the position is a capital letter. This allows one to determine the positions of the two aircraft at the same time. The plotter uses the capital letters in alphabetical order. This feature makes it possible to determine the direction in which the aircraft were flying the tracks. After each alphabetic character, a decimal character is plotted which indicates the aircraft's Mode C altitude at that point in hundreds of feet. Different symbols are used for the two aircraft to plot the other intervening points. The runways at Houston are also plotted.

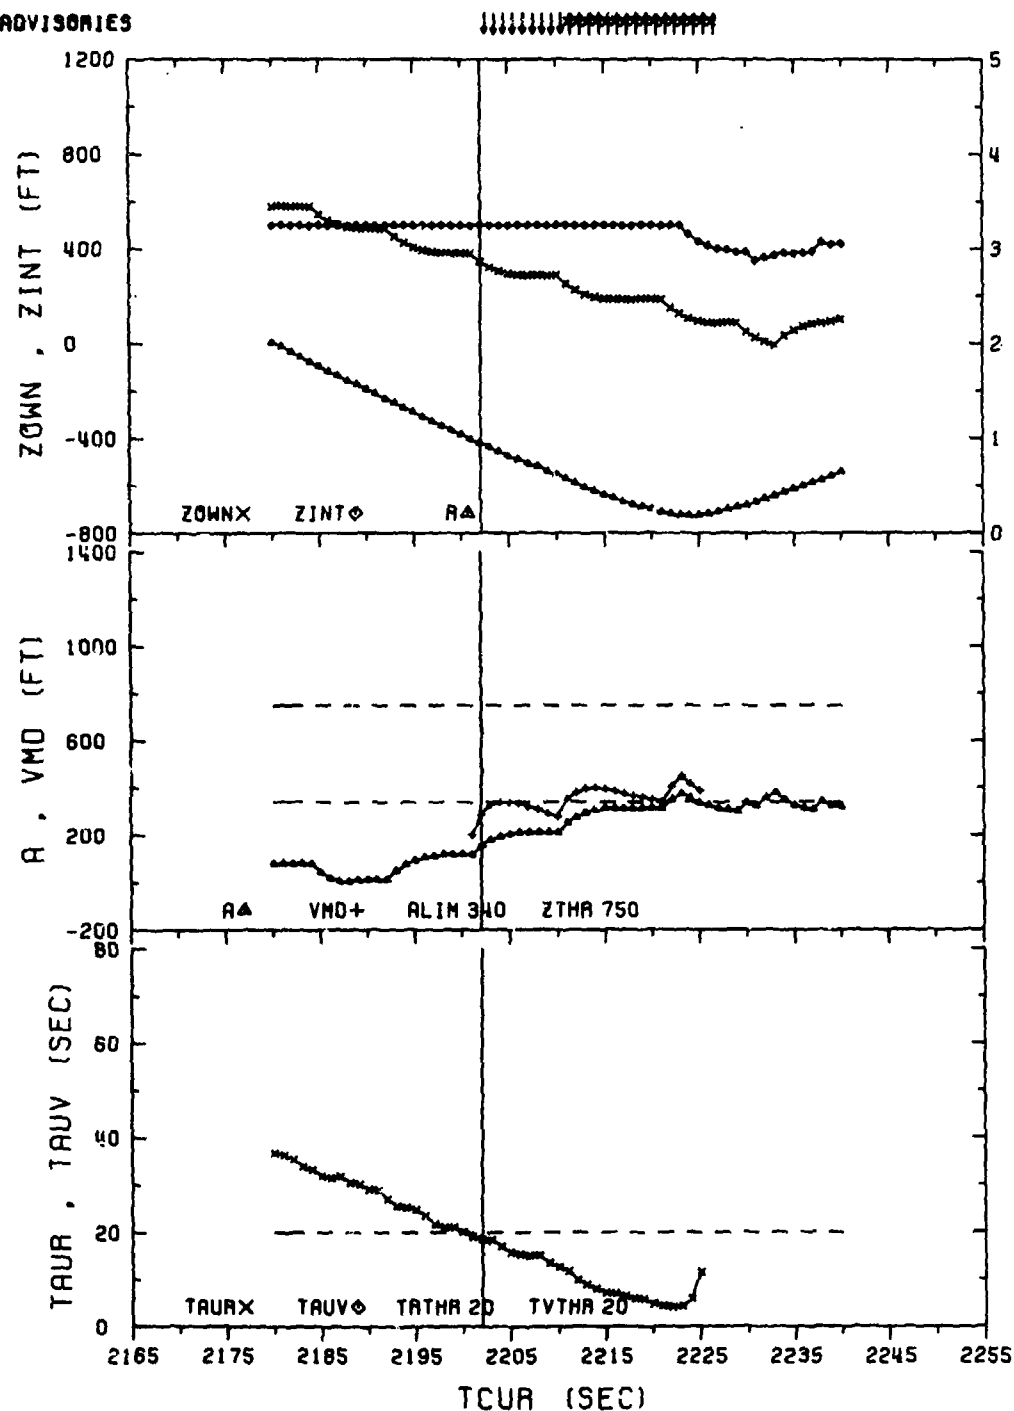
FIGURE 4-4
SEPARATION, TAU PLOTS FOR ENCOUNTER 2 AT HOUSTON

The BEU produced a descend advisory which was converted to a don't climb for the display, which was correct. However, it was subsequently determined that there was a hardware problem in the BEU related to this descend inhibit feature. This problem caused the descend inhibit rule to be applied in situations much higher than 500 ft AGL. This problem was discovered during the planned encounters at Los Angeles, when don't climb advisories appeared during encounters in which the pilot was expecting a descend. The problem was corrected at Los Angeles. The BEU advisory sequences in Table 4-1 show what advisories the BEU calculated, but do not necessarily indicate the advisories that were displayed to the pilot.

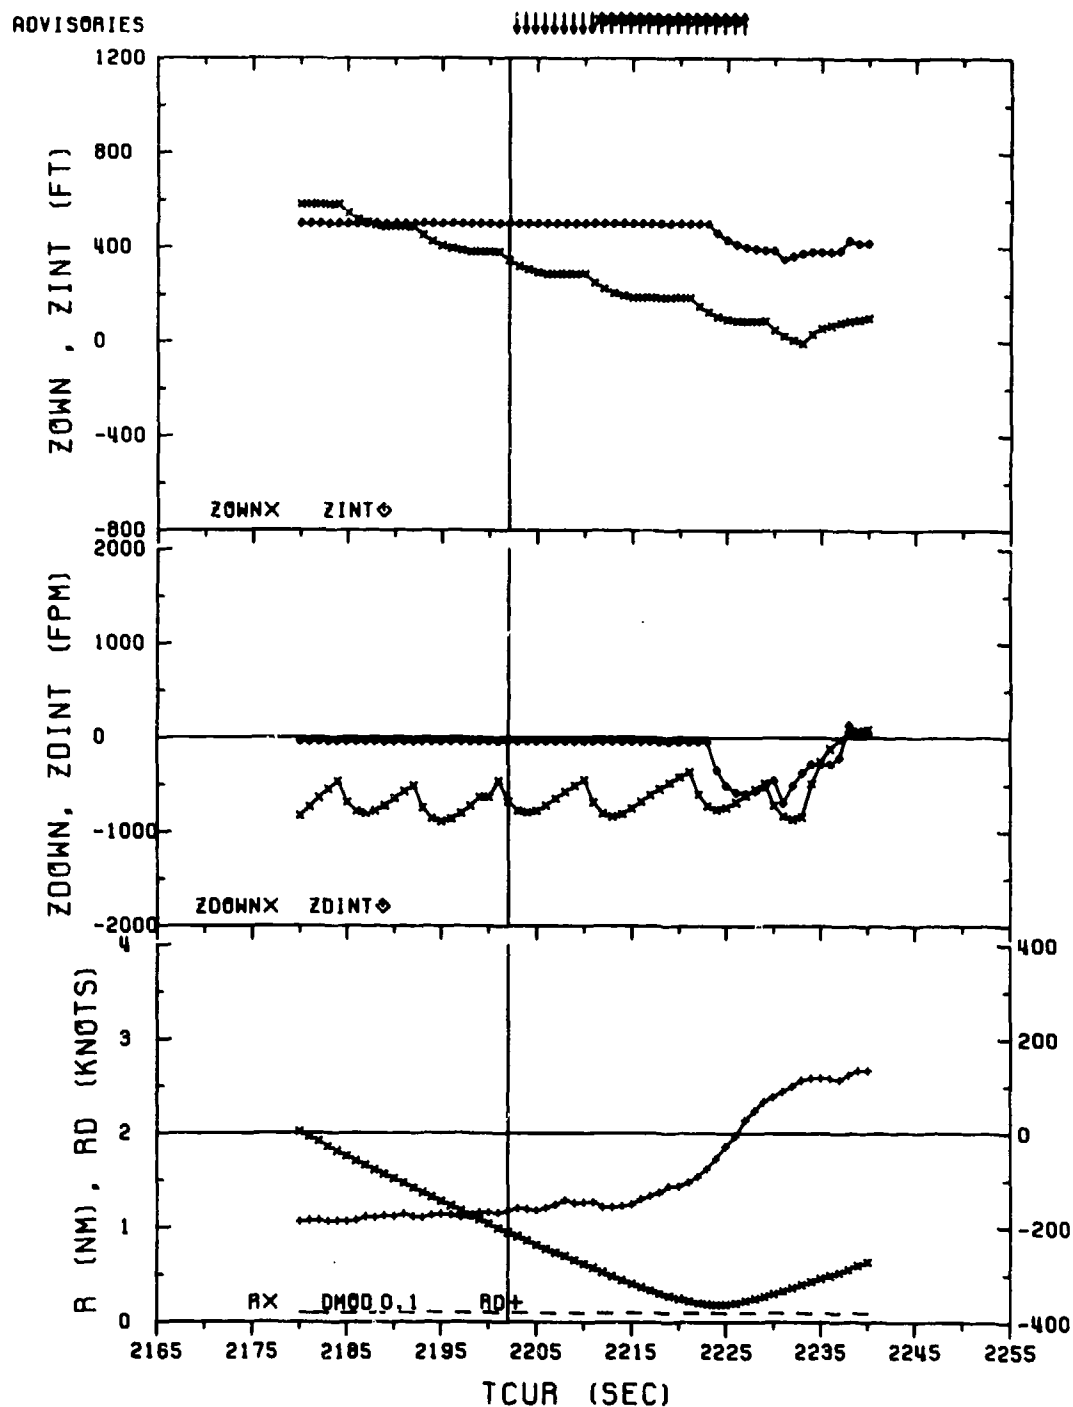
FIGURE 4-5
SEPARATION, RATE PLOTS FOR ENCOUNTER 2 AT HOUSTON

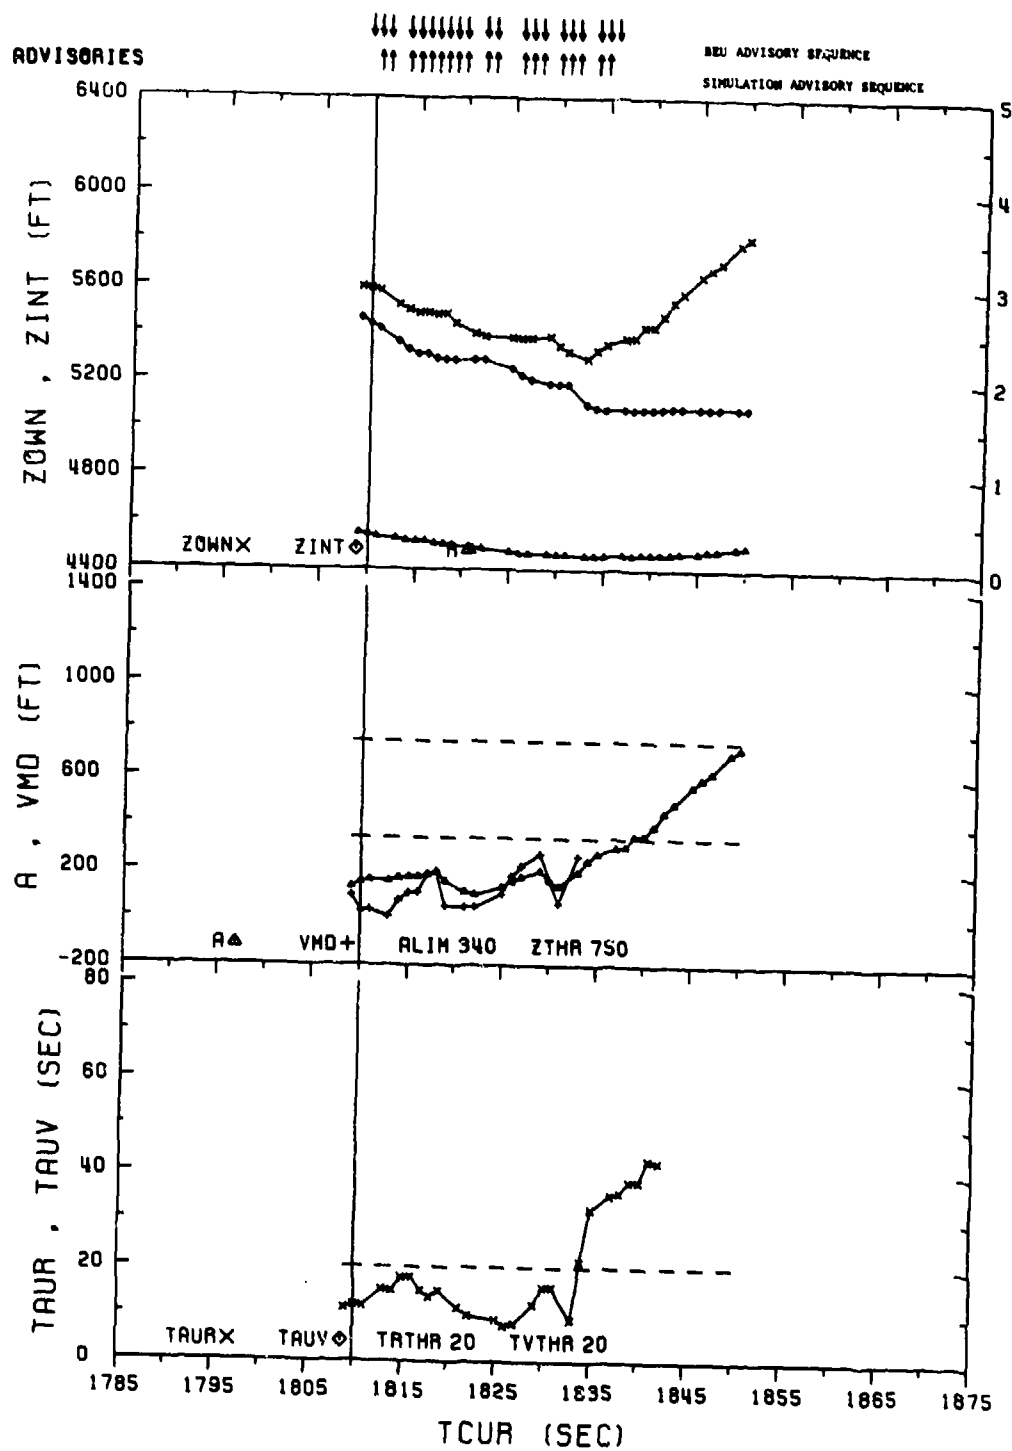
FIGURE 4-8
SEPARATION, TAU PLOTS FOR ENCOUNTER 4 AT DENVER

Figure 4-8 shows that the simulation calculated a climb advisory. However, the BEU calculated a descend advisory. (Recall that a descend advisory is converted to a don't climb advisory when below 500 ft AGL. However, this conversion takes place outside the BEU computer and is not reflected in the recorded data.) Since all data is missing from the tape just prior to the advisory sequence, the cause of this discrepancy cannot be conclusively established. However, because all of the alert variables are well below threshold on the first cycle of data, it is evident that the BEU had chosen a descend based on earlier data. It is presumed that the descend was the correct choice at that time. At the time the simulation generated the advisory, the aircraft were within 100 ft of each other in altitude. It is entirely plausible that shortly before that time they were even closer vertically, so that a descend would have been appropriate.

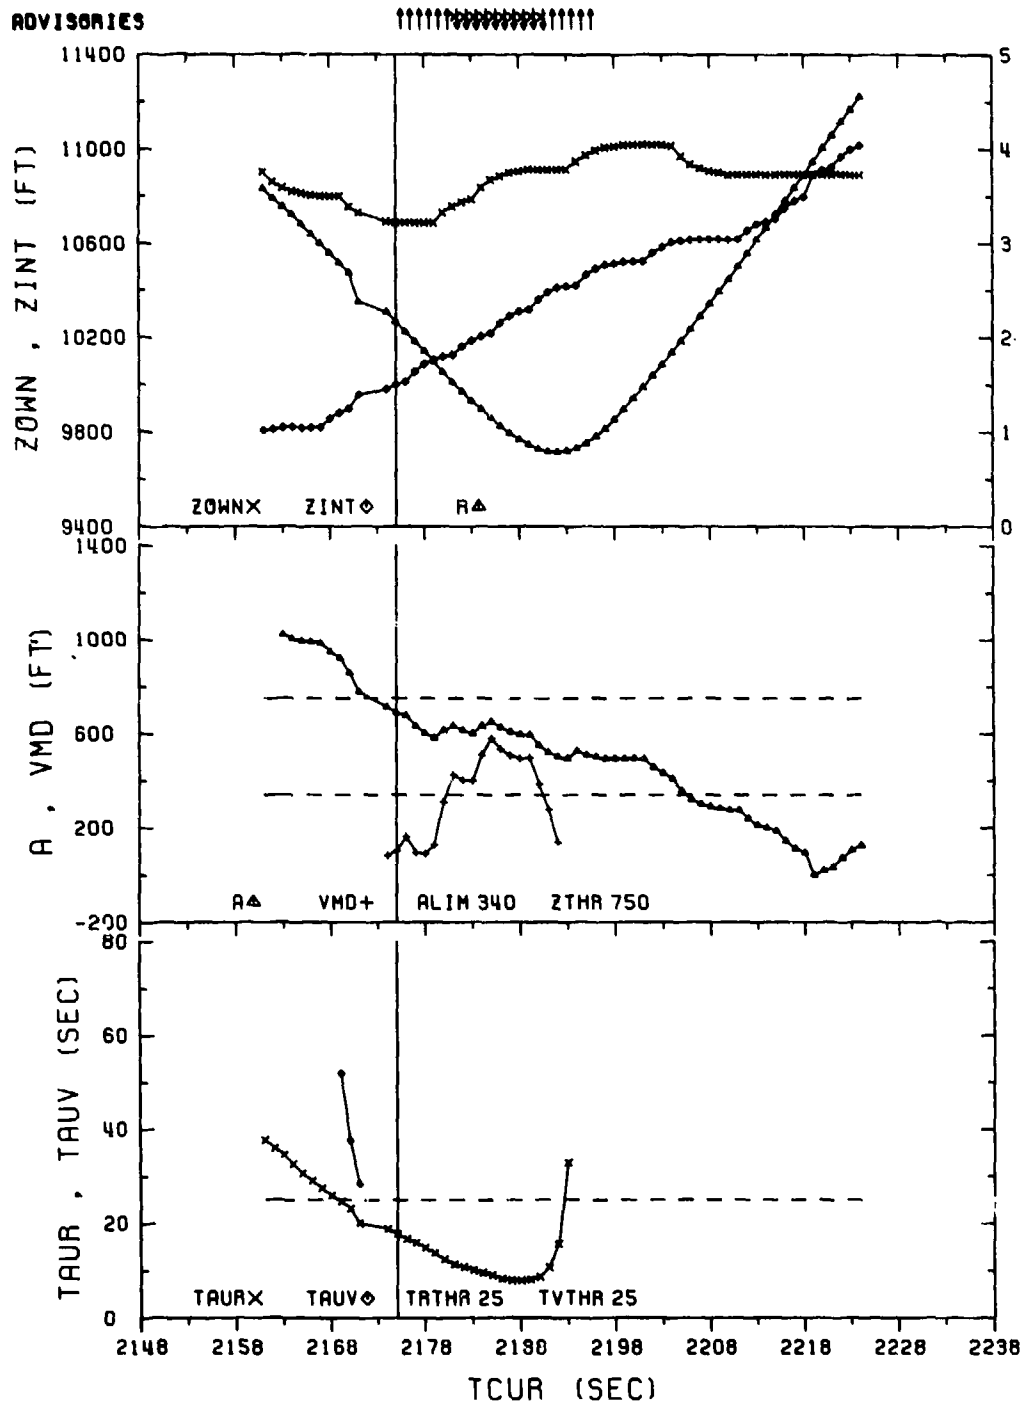
FIGURE 4-10
SEPARATION, TAU PLOTS FOR ENCOUNTER 5 AT DENVER

to negative. The BCAS aircraft responded to the negative advisory, Don't descend, by leveling off. After the level-off, VMD dropped below ALIM and the advisory transitioned back to positive. VMD alone was used to determine the severity of the advisory since the intruder had a rate greater than 1000 fpm (see Figure 4-11). This is an example that shows how the BCAS logic gives an earlier alert against an unequipped intruder with a high converging vertical rate.

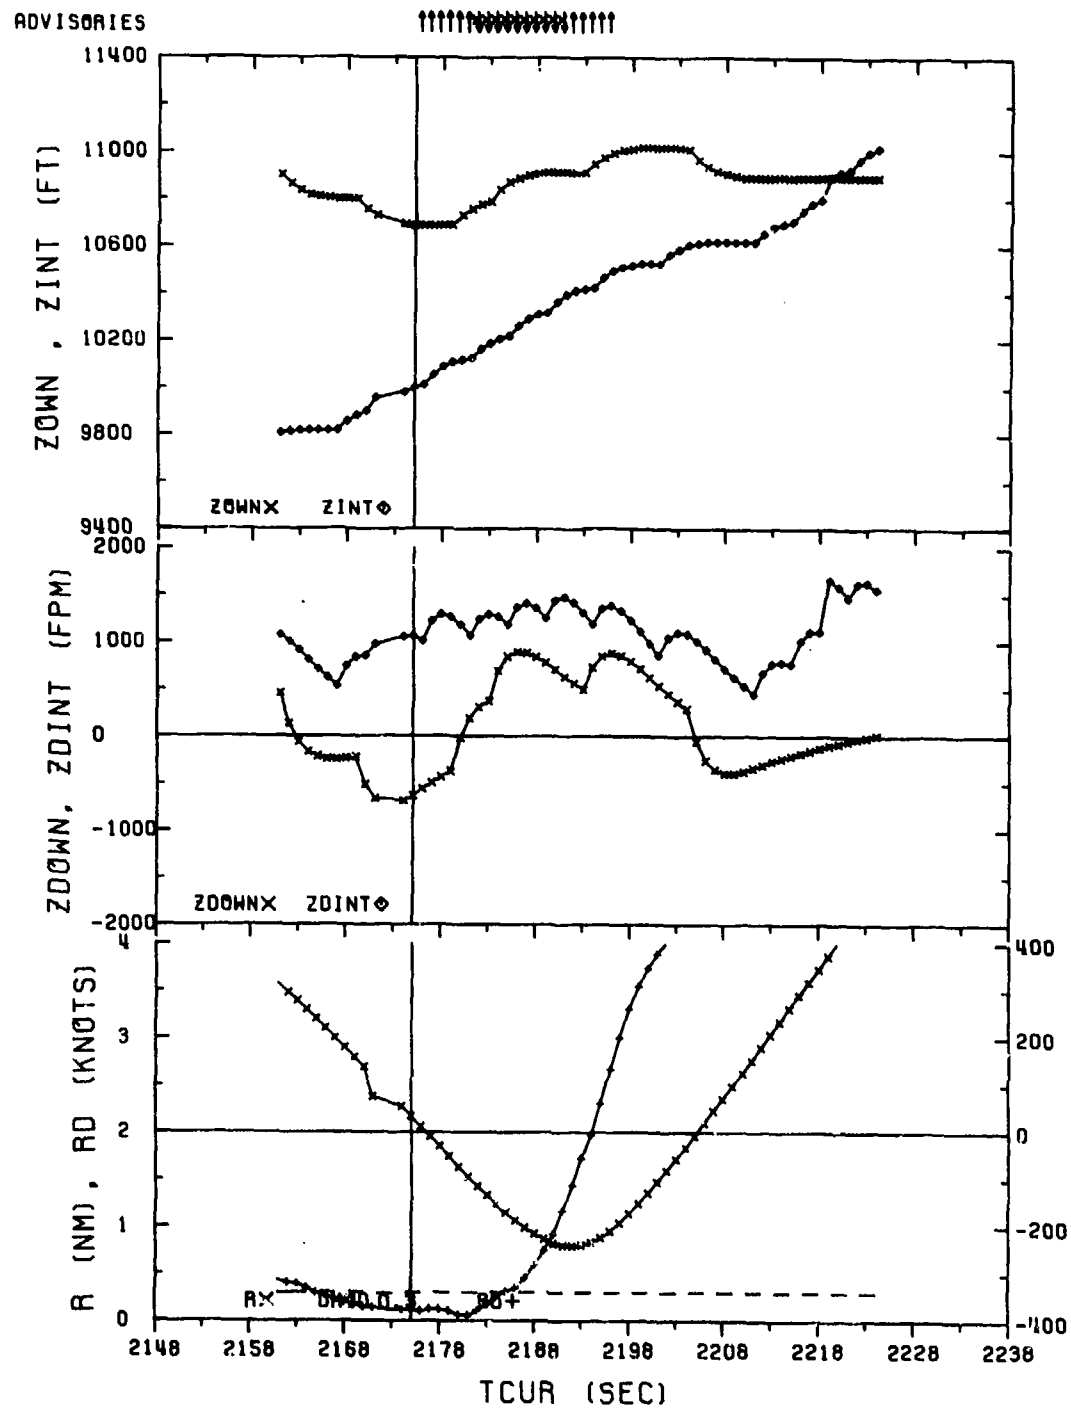
FIGURE 4-11
SEPARATION, RATE PLOTS FOR ENCOUNTER 5 AT DENVER

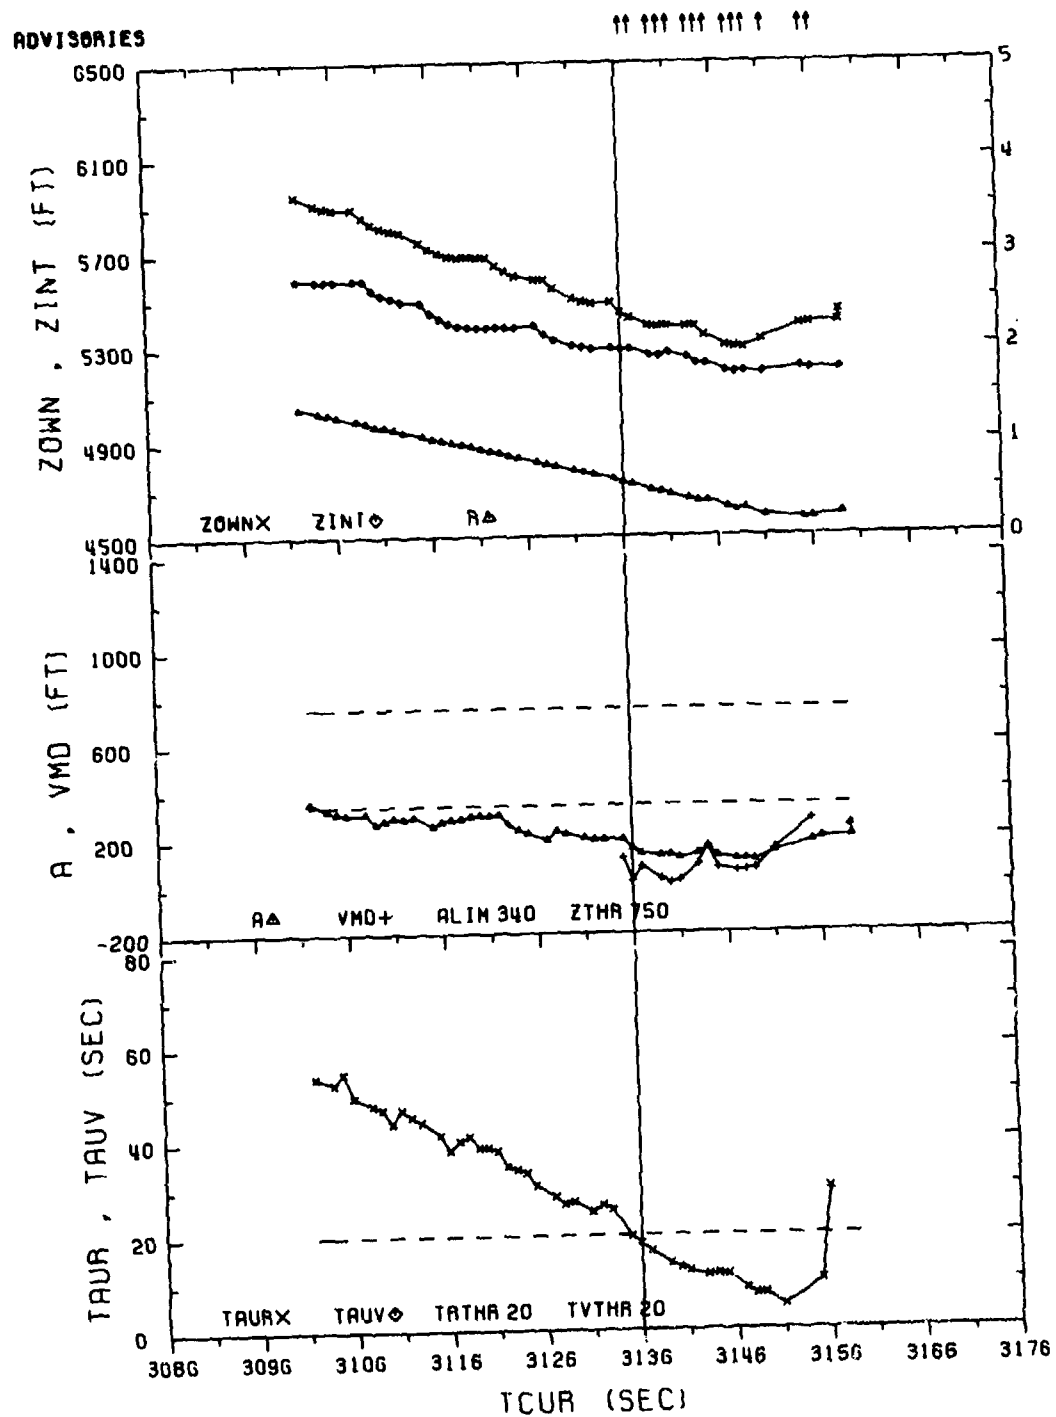
FIGURE 4-12
SEPARATION, TAU PLOTS FOR ENCOUNTER 6 AT DENVER

The encounter shown in Figures 4-12 and 4-13 also occurred on short final. The BCAS aircraft was approaching runway 26R and the threat aircraft was approaching runway 26L. At the time of the advisory the BCAS aircraft was at 400 ft AGL. The threat aircraft touched down just after the advisory appeared. In this encounter, as in encounter number 4, the advisory appeared during a period of critical pilot workload. The range at closest approach was about 1000 ft because the aircraft were in an approach pattern to parallel runways that are separated by only 900 ft.

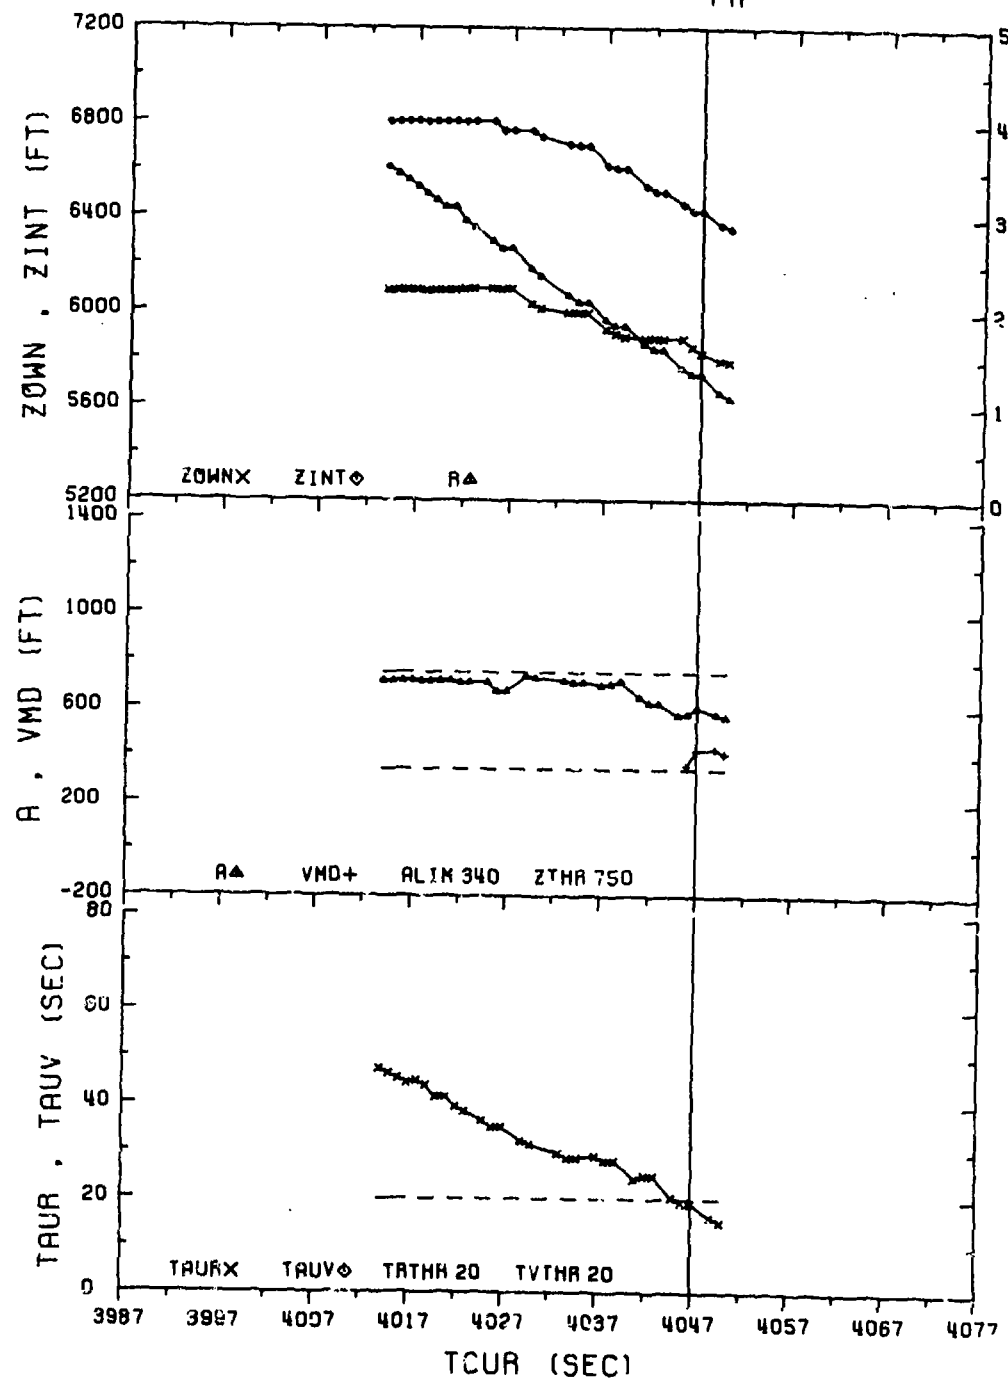
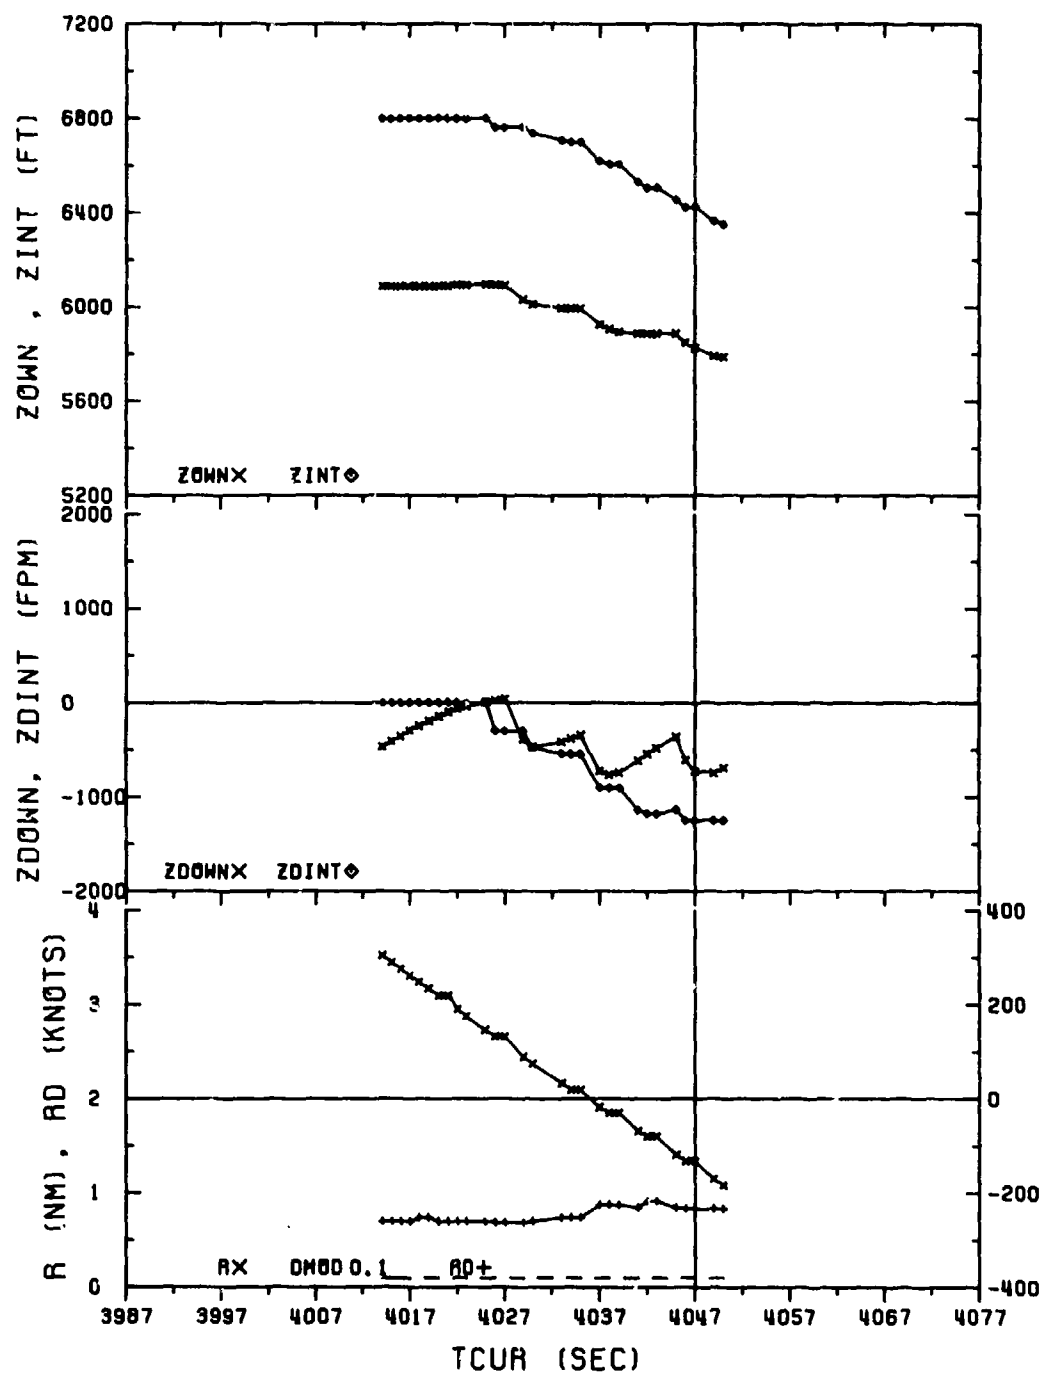
FIGURE 4-14
SEPARATION, TAU PLOTS FOR ENCOUNTER 7 AT DENVER

FIGURE 4-15
SEPARATION, RATE PLOTS FOR ENCOUNTER 7 AT DENVER

is the encounter shown in the figures. For this geometry, don't climb was the correct advisory. There is enough history on this track that it appears to be a valid track. The BCAS system was also tracking the aircraft that was visually sighted by the pilot, but did not generate an alert because of it. The data for this aircraft is plotted in Figures 4-16 and 4-17. At the time of the alert (system time 4047) this aircraft was at a range of 0.4 nmi and was 100 ft below the BCAS aircraft. The rate of closure with this aircraft was small, so that the value of TAUR never dropped below TRTHR. In fact, TAUR is large enough that it does not appear on the plot.
